Subject: Suspected Chlorine Gas Release Clean Up Report Located in Spokane, WA

Clean Harbors Environmental Services is pleased to present to you this report for the chemical vapor release emergency response and cleanup located at Pacific Steel & Recycling in Spokane, WA.

Pacific Steel and Recycling

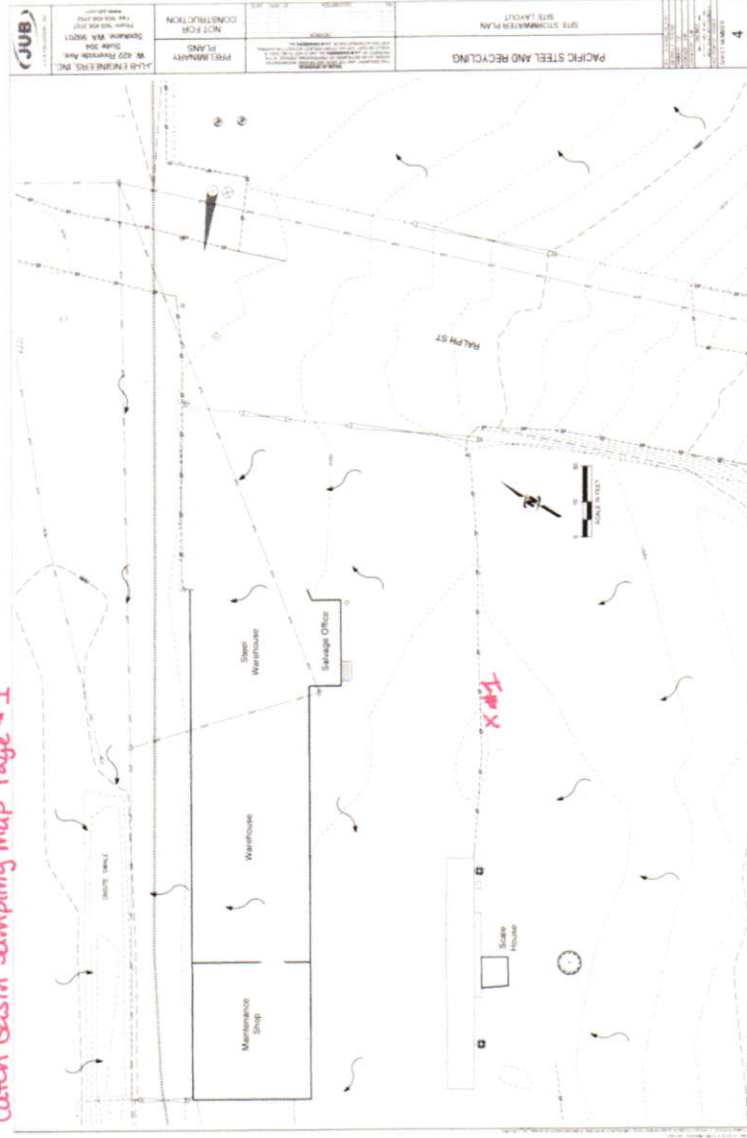
Catch Basin Sampling Map Page #1

Catch Basin/OWS Map Page 1

At 7:00 PM CHES personnel pulled samples from all catch basins and sumps in accordance with the sampling plan and tested for pH level. All results showed a pH of 7 and no cleaning or decontamination was required. All CHES equipment was stowed and all CHES personnel left site by 8:00 PM.

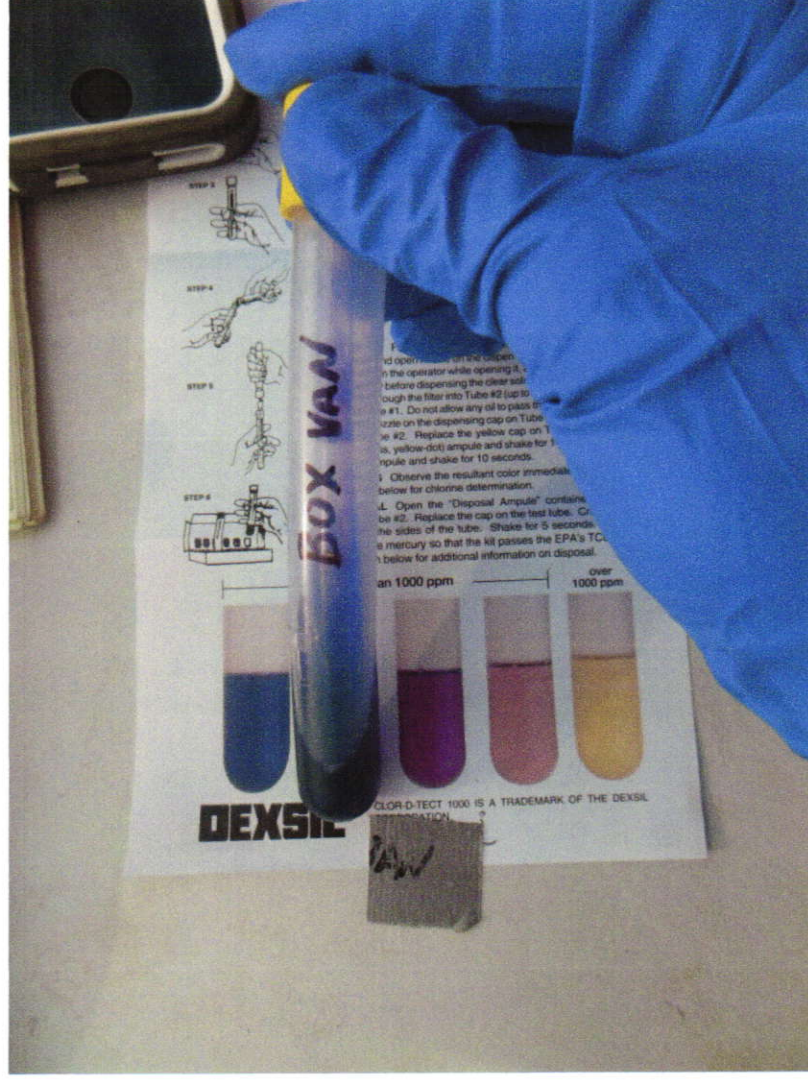
Pacific Steel Box Van

Clor-D-Tect Results

<1000 ppm Chlorine

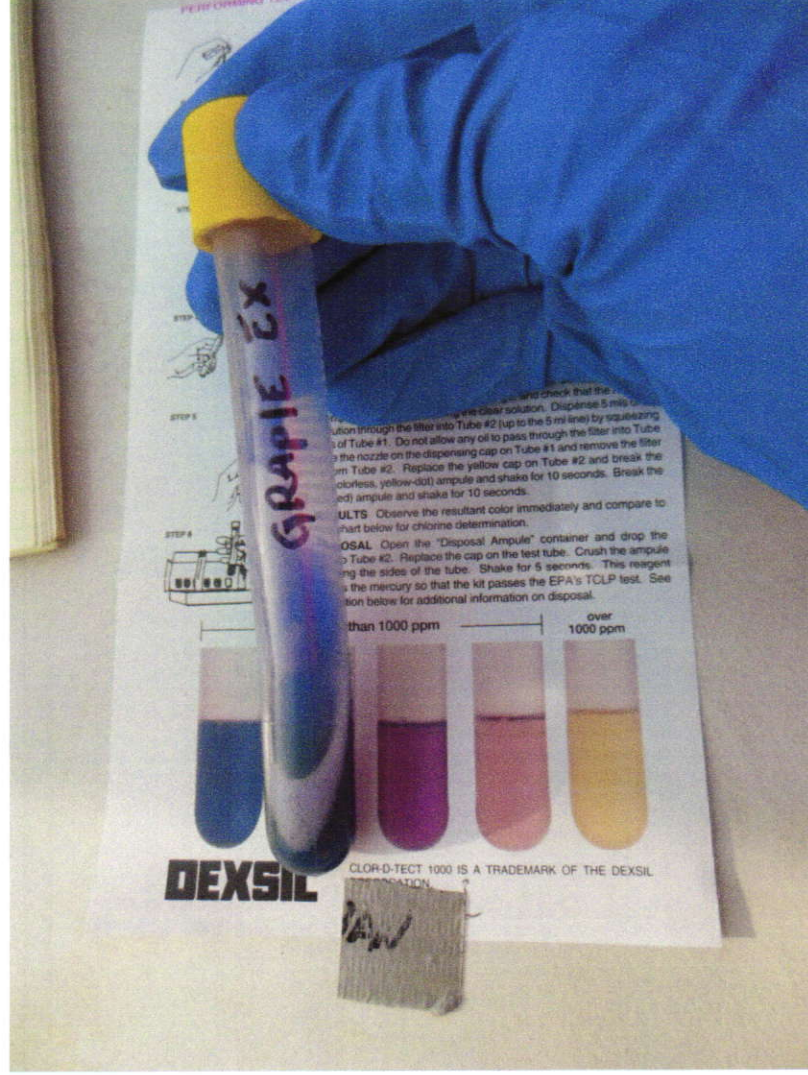
Excavator with Grapple

Clor-D-Tect Results

<1000 ppm Chlorine

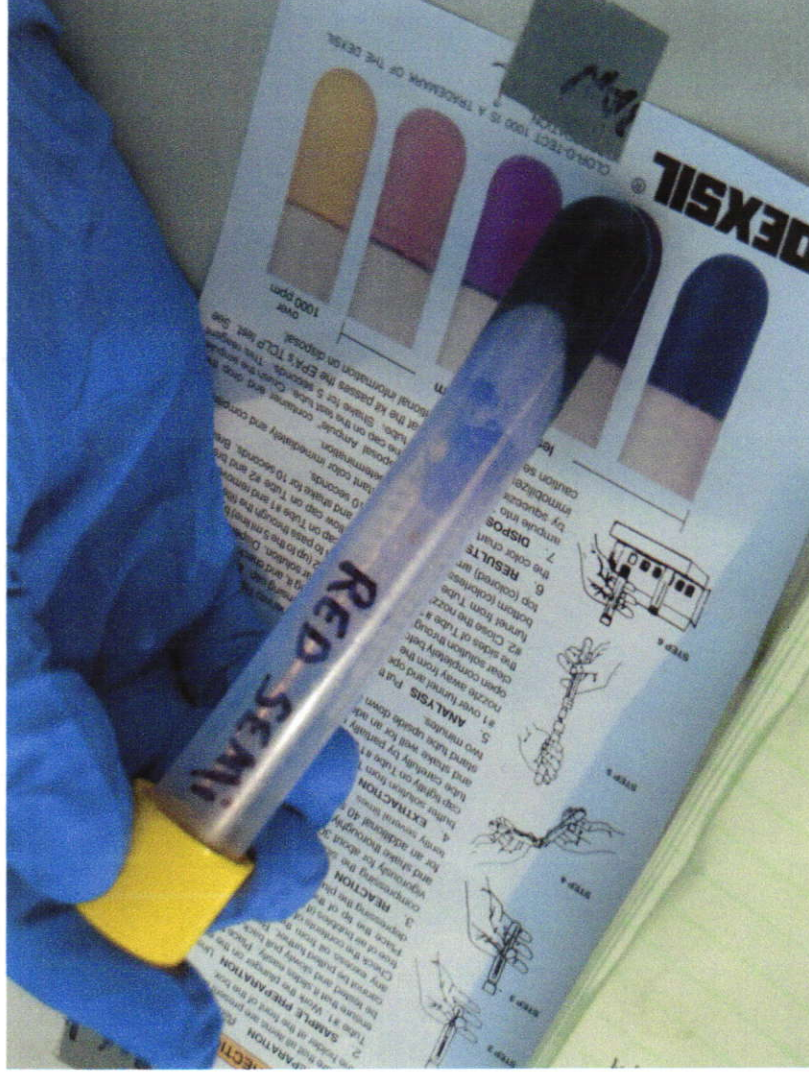
CAST Transportation Tractor

Clor-D-Tect Results

<1000 ppm Chlorine

At the request of PSR CHES crews returned to wash and decontaminate CAST trucking tractor and flatbed trailer. Initial testing of these vehicles did not show any contamination, but a cleaning was requested to ensure no contamination prior to releasing the vehicles to CAST.

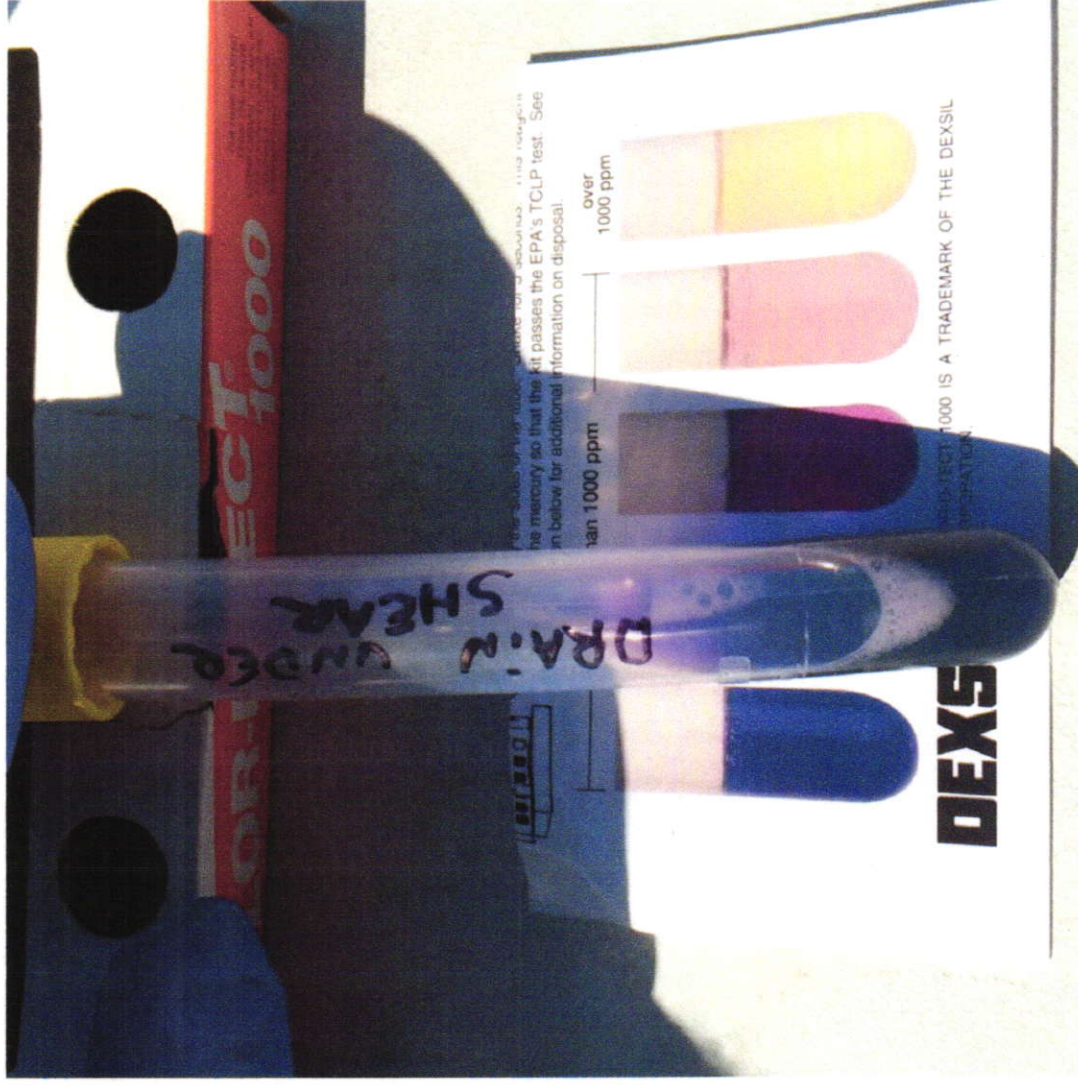
Oil Drain Under Shear

Clor-D-Tect Results

<1000 ppm Chlorine

At 9:15 AM CHES performed an entry into the exclusion zone with a two man crew in level C PPE to decontaminate and clean the oil contamination from the bottom of the Metso shear. The oil contamination was more widespread than initially thought and difficult to clean requiring additional personnel to make an entry to assist. CHES performed an entry in the exclusion zone with a four man crew in level C PPE at 10:15 to finish the cleanup and decontamination of the Metso shear. Sampling and re-testing after the cleanup were negative (<1000 ppm) for chlorine.

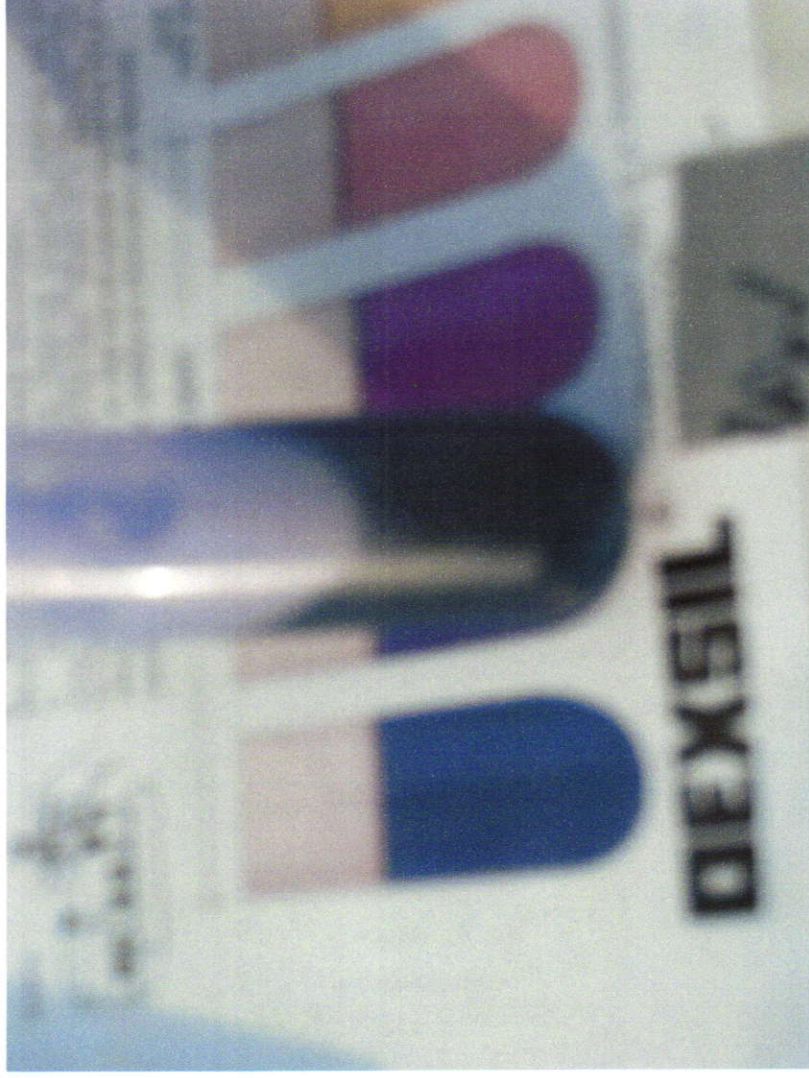
Base of Metos Shear post
decontamination

Clor-D-Tect Results

<1000 ppm Chlorine

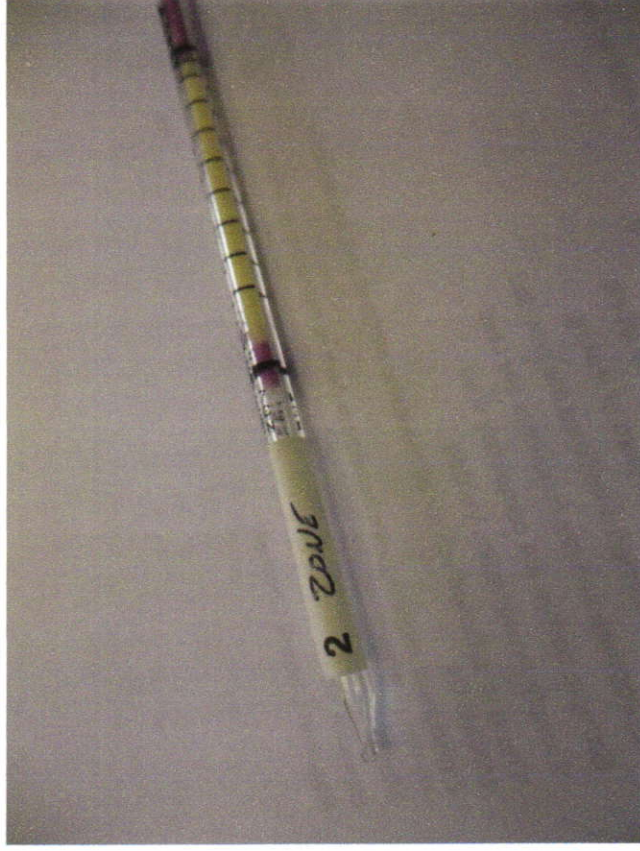
Colormetric Chlorine Test

General Area – No Detection

At 1:30 PM CHES performed an entry into the exclusion zone with a two man team in level B PPE and conducted air monitoring via colorimetric tubes around the cylinder carcass and surrounding area for chlorine gas. All tests were negative. CHES personnel also conducted pH spot testing on various areas of the cylinder; pH tests were positive for a low pH reading of 3. CHES took additional pictures of the cylinder at this time. These pictures were sent to Clean Harbors Cylinder Group in La Port, Texas. A 100% positive determination of the contents of the cylinder could not be made, but the CHES Cylinder Group did confirm that the cylinder in question could potentially have contained chlorine gas based upon of the valve configuration and general appearance of the cylinder.

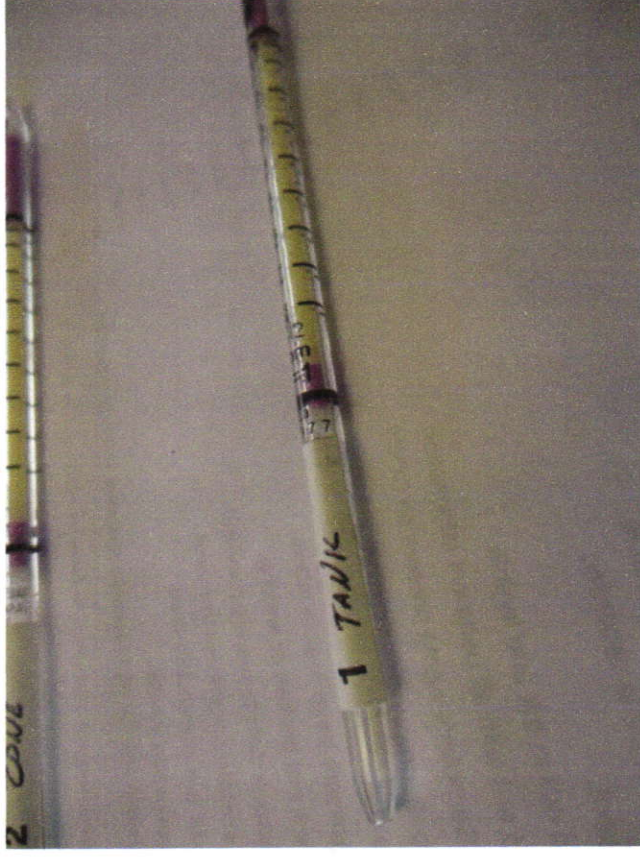
Cylinder – No Detection

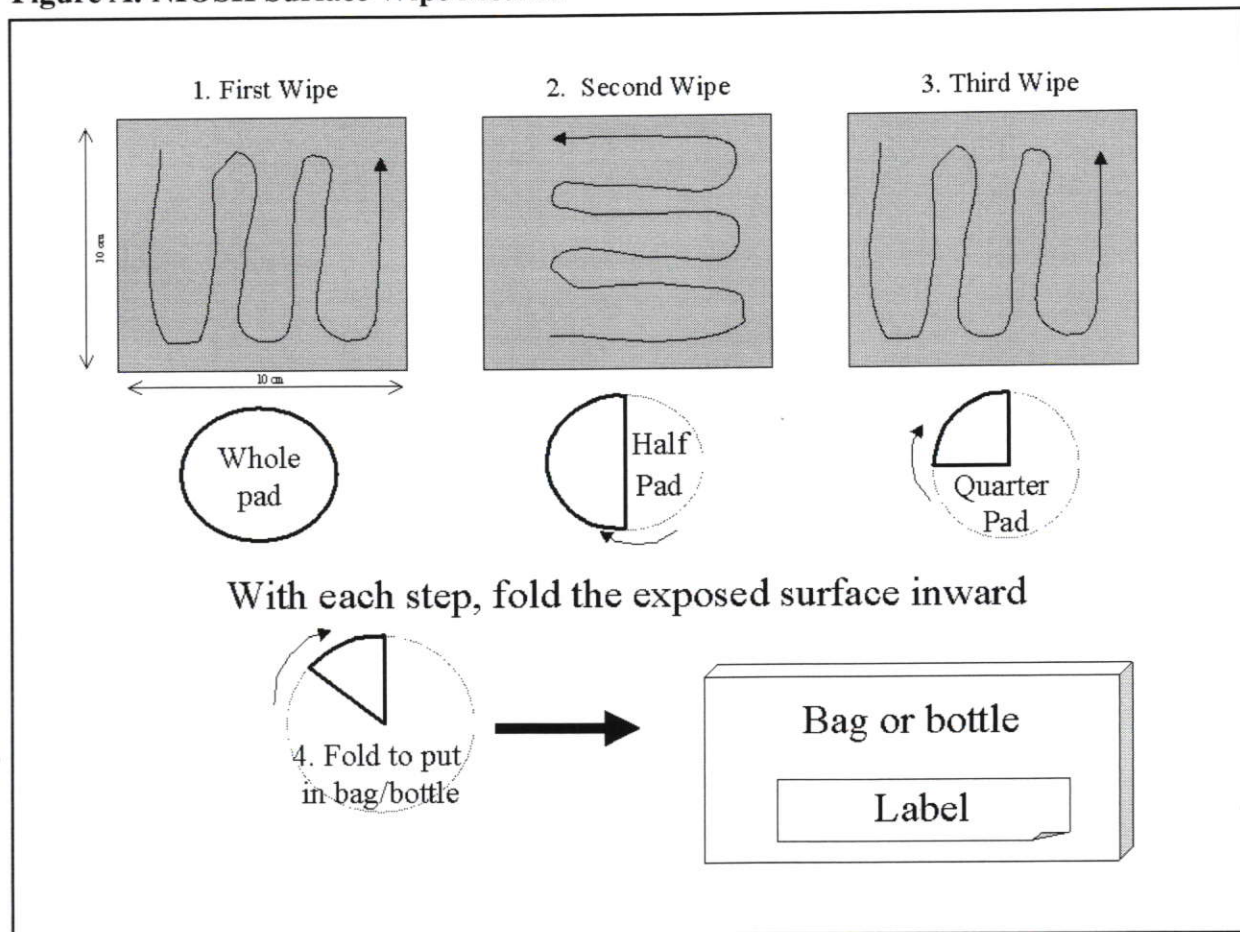
Figure A: NIOSH Surface Wipe Method

- b. **Wipe Technique:** CHES has selected the NIOSH method of collecting wipe samples. For uniformity, this method should be used for all sampling surface to be sampled (Visually depicted in Figure A)

- iii. Wipe the surface with firm pressure, using S- strokes (edge to edge direction, covering the entire surface. Note: See Figure A for the pattern of an S-stroke used in this method. It may differ from the S-stroke pattern used in radiological sampling). Fold the exposed side of the pad or filter inward (i.e. fold in half). If the surface is very rough (such as concrete), a dabbing action may be substituted for the full contact pressure rubbing of the media across the surface. When dabbing, make sure to completely cover the same area as in the S-stroke wipe.

- iv. Using the once-folded media, wipe the same area S-strokes (see Figure A), at right angles to the first wipe. Fold the exposed side of the pad or filter in.

- v. Using the twice-folded media, wipe with S-strokes (see Figure A) in the original direction. Fold the exposed side of the pad or filter in.
- vi. Place the media in the Jar. Seal the Jar. Record the sample identification on the Jar.
- vii. Thoroughly clean reusable templates or discard paper templates in preparation of the next sample.
- viii. Remove gloves and discard appropriately before handling the next filter or pad.
- ix. Record the sample identification, surface area sampled, and description of the sample and surface.
- x. Include 1 blank filter or pad (moisten and placed in bags or vials) with each set of samples (provide 1 blank per 6 samples).
